HISTORY OF A LANDFILL SITE NEAR LAS CRUCES, NM

April Lewis, Environmental Research Institute of Michigan

Ed Van Eeckhout, Los Alamos National Laboratory

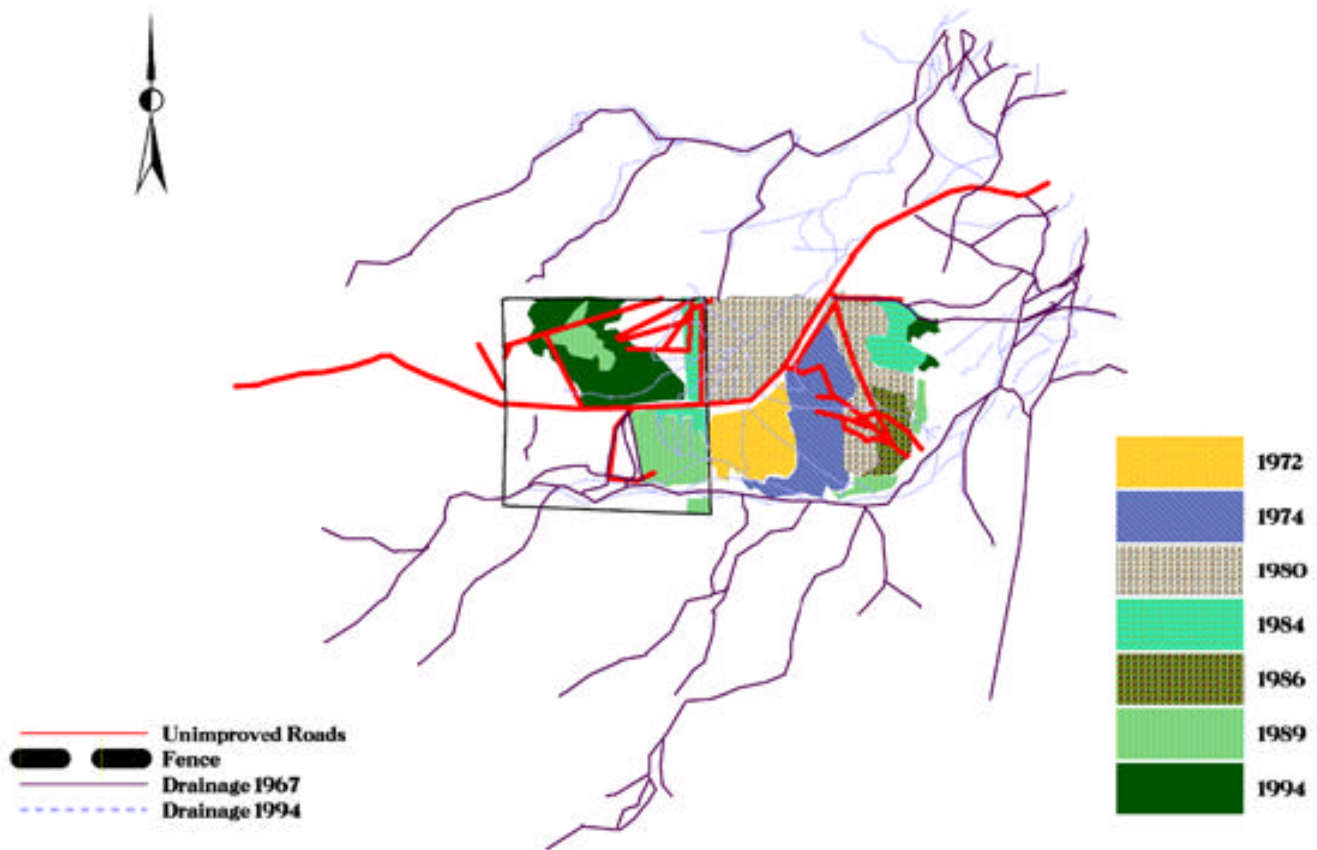
Fig. 3. Vector map created from animation of multigate imagery.

The multigate images were trimmed and exported as raw data files. These images were fed to a transformation process so they could be registered to a base image. In this study, the 1994 photo served as the master image. All the photos were vertical, requiring only rotation, scaling, and translation to match the master image. A program called MOTIFSHO was used to coregister, warp, and animate the site images. The coregistration and animation of multigate imagery provide an accurate time line analysis or change mapping of the site. As a direct result of the animation, a vector map was created which reveals the annual growth of the site from 1955 through June of 1994. Figures 3 and 4 describe that growth.

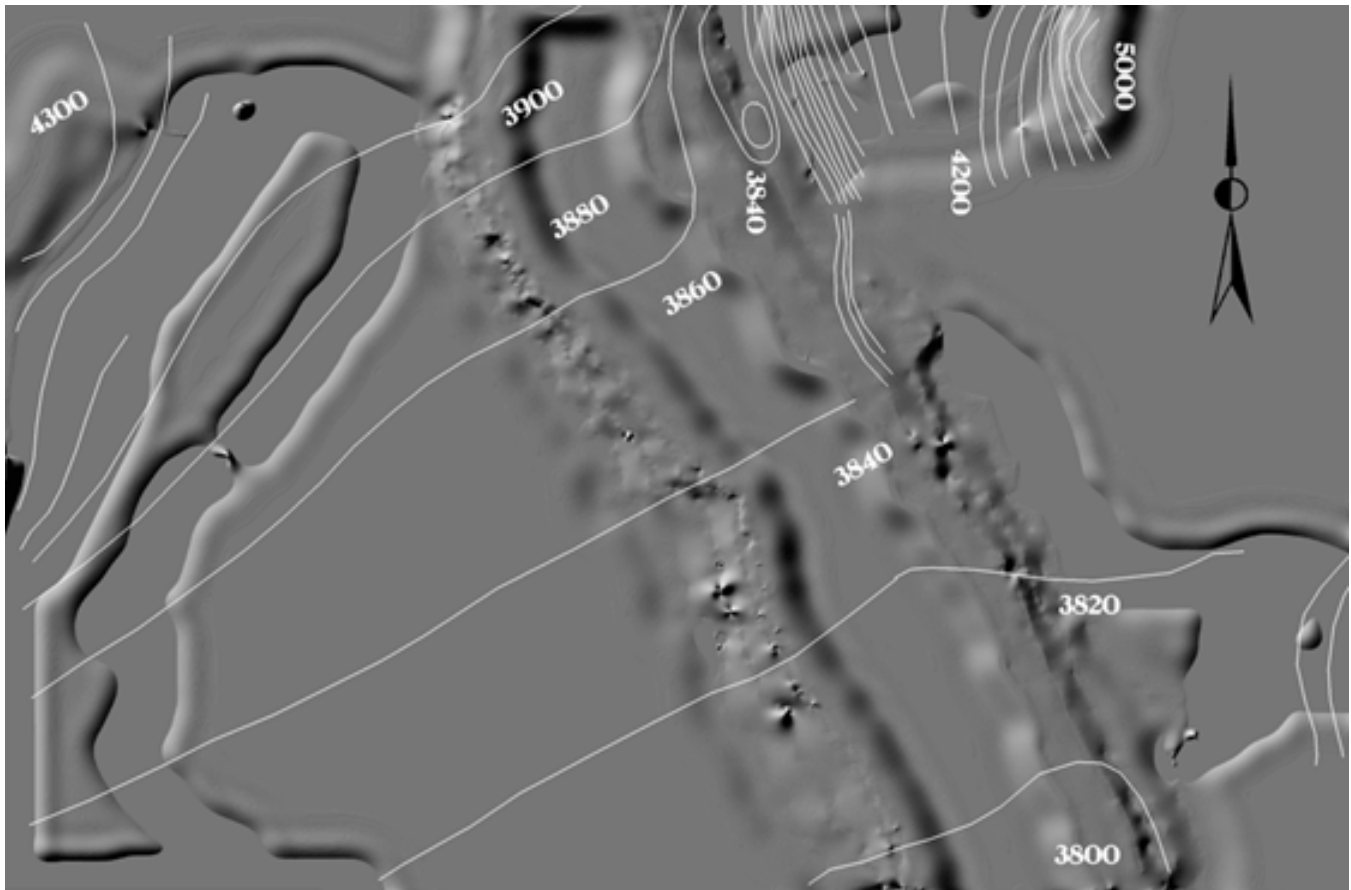
Fig. 5. Water gradient vector map.

for water gradient contours. In general, the ground-water in this region occurs under confined conditions, because clay has reduced the vertical permeability. (Wilson, 1981)

Ground-water moves southeastward beneath the West Mesa area, eventually converging with the water in the southern Mesilla Valley. Ground-water discharge occurs throughout both areas as drain flow to the river and evapotranspiration. Large surface-water irrigation allotments increase ground-water recharge, which improves the shallow ground-water quality neighboring these areas. Shallow ground-water discharges to drains which flow into the Rio Grande.
